Manhole Inspection Summary

Manhole # S27C__011MH

Insp Date: **12/7/07 1:30 PM**

Location Address: **501 FREMONT AVE**

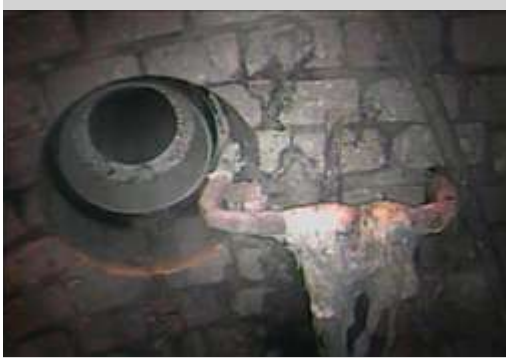
Defect 1

☒ **Evidence Of Surcharge** Depth: **4** (ft.) ☐ Active Surcharge Present

SURCHARGE EVIDENCE ON STEPS

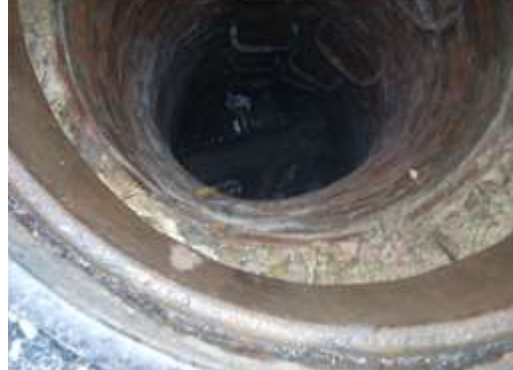
Defect 4

Offset: **0** (in.)

FRAME OFFSET

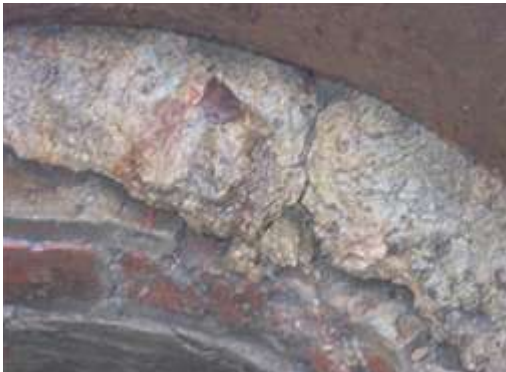
Defect 3

Condition: ☐ Sound ☐ Cracked ☐ Root Intrusion ☐ Loose Brick ☒ **Deteriorated**

DETERIORATED CHIMNEY

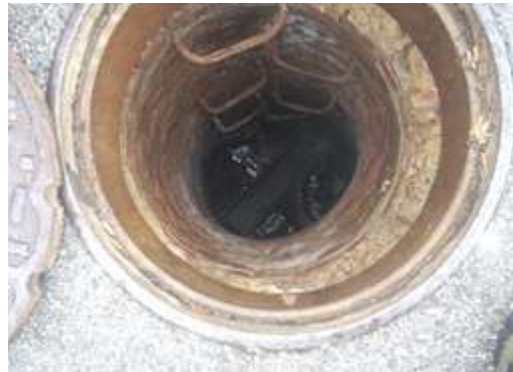
Defect 2

Count: **8** Missing: **0** ☒ **Corroded**

CORRODED STEPS
